RESPONSE OF UN-CRACKED DRYWALL JOINTS AND SHEETS TO BLAST VIBRATION AND WEATHER

CHARLES H. DOWDING¹

JEFFREY E. MEISSNER²

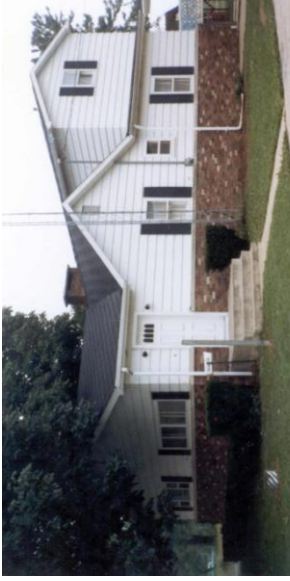
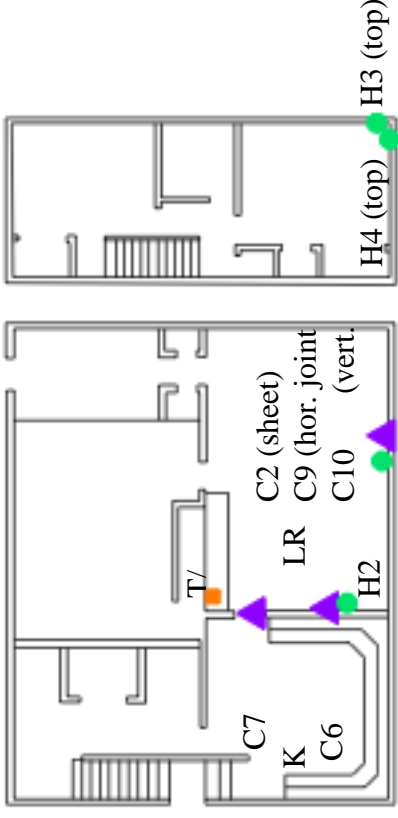
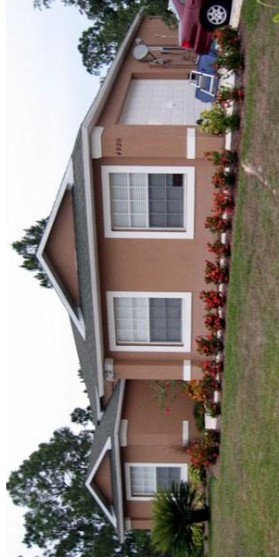
Figure 1 - Photographs and plan views of test structures. Top: Blanford, IN Bottom: Naples, FL

Measurements described herein were obtained in two houses whose photographs and floor plans are shown in **Figure 1**; one in Blanford, Indiana and the other near Naples, Florida. Two uncracked drywall joints and a cracked drywall joint in the living room of the Indiana house were instrumented for comparison. Multiple sections of the house shown in the photograph were built over a period of 10's of years, with the middle the oldest and the right most, two-story section the newest. Each section is built on a basement, with a full basement under the two-story section, a shallow basement beneath the middle, and a crawl space beneath the left (Dowding, 1996). The walls, interior and exterior, are constructed of standard wood studs and were covered in drywall for the observations. One drywall joint in the garage ceiling of the Florida house was instrumented for this study. The Florida house is a slab on grade structure, whose exterior covered walls are built with concrete masonry units (CMU), and interior walls and ceilings were constructed of wood studs and gypsum drywall (Kosnik, 2009).

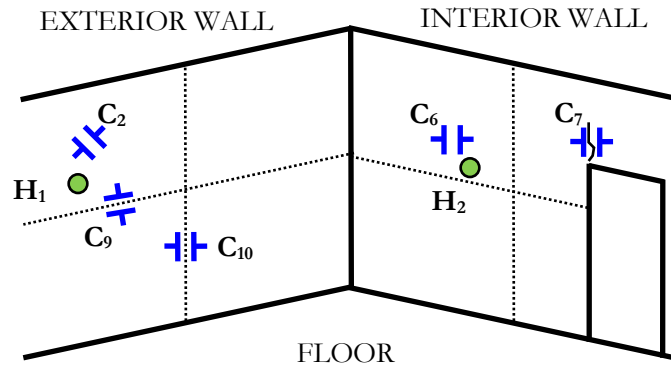
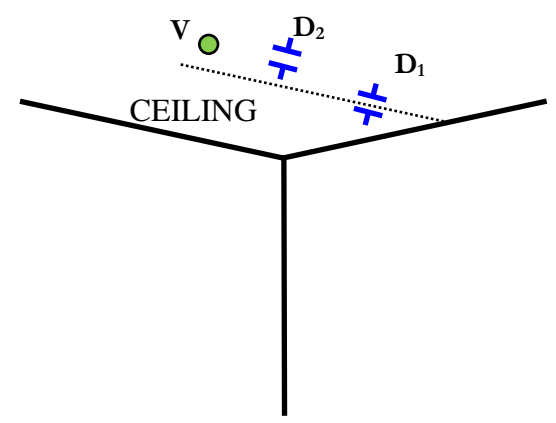
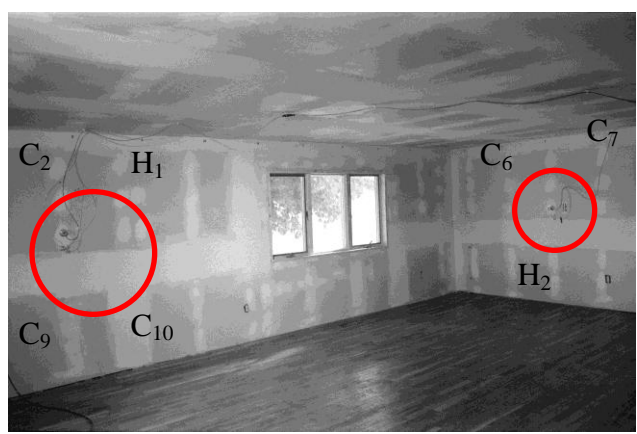
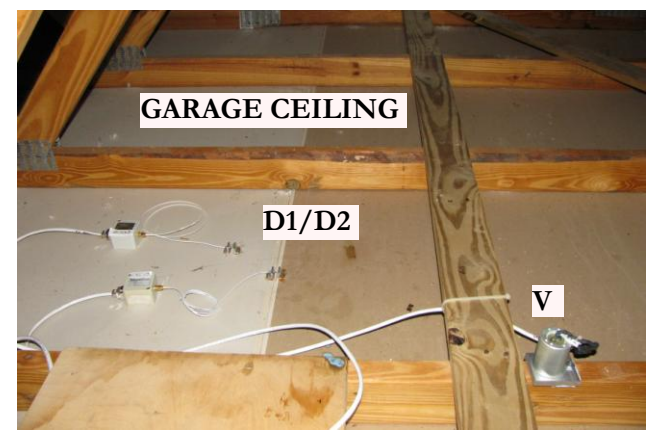
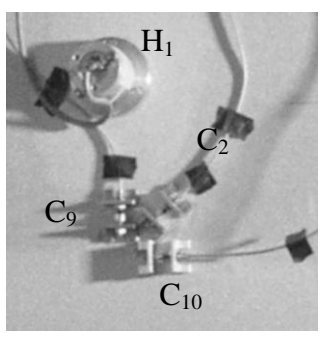
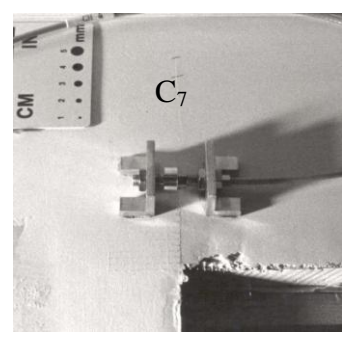
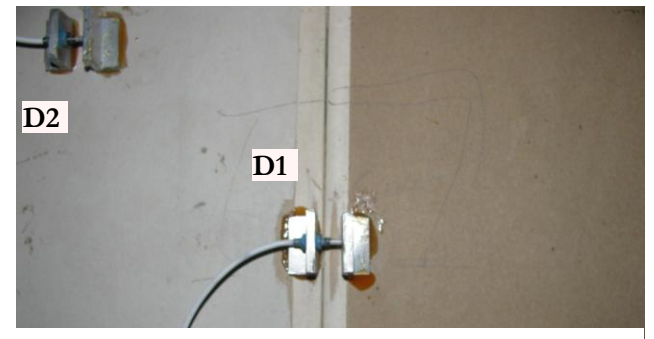
Figure 2 - Installation details for the Indiana (left) and Florida houses (right). Wall, joint and sensor orientation are illustrated on the top row. Photographs showing context are in the middle row and with detail on the bottom. C9&10&D1 cross un-cracked drywall joints; C7 crosses a cracked drywall joint; and C2&6&D2 are located on drywall sheets.

Joints between gypsum dry wall sheets were chosen for measurement because they are the weakest sections of dry wall installations. Gypsum dry wall is the dominant interior wall covering in the United States, and is affixed to the structure by nailing/screwing $\frac{1}{2}$ to $\frac{3}{4}$ inch thick, 4 ft by 8 (or 12) ft sheets to the frame wall. Joints between these sheets are connected with a paper tape, which is in turn covered with a thin coating of plaster. These joints are the vertical and horizontal white stripes in the photograph in the middle left in **Figure 2**.

Context (top) and details (bottom) of the instrument installations are shown in **Figure 2** with those for the Indiana house on the left; Florida house on the right. The living room walls in the Indiana house contain the instrumented dry wall joints as shown in the drawing and center photograph. Horizontal and vertical un-cracked dry wall joints are C9 and C10. Uncracked locations near the centers of the drywall sheets are C2 and C6. Drywall joint crack, C7, shown in the bottom right most photograph, is at the doorway (adjacent to C6) between the living room and the kitchen. This crack is not fully extended, and did not extend during the observation period. Out-of-plane, mid-wall motions were measured with velocity transducers as shown in the bottom left photograph.

Similar information for the instrumented garage ceiling drywall joint in the Florida house is shown on the right of **Figure 2**. Sensor D1 spans the joint and D2 is nearby on the full section drywall. They are installed on the attic, upper, or uninhabited side of the garage ceiling as can be seen in the center photograph. As with the wall measurements, out-of-plane ceiling responses were measured with a velocity gauge as shown in the middle photograph.

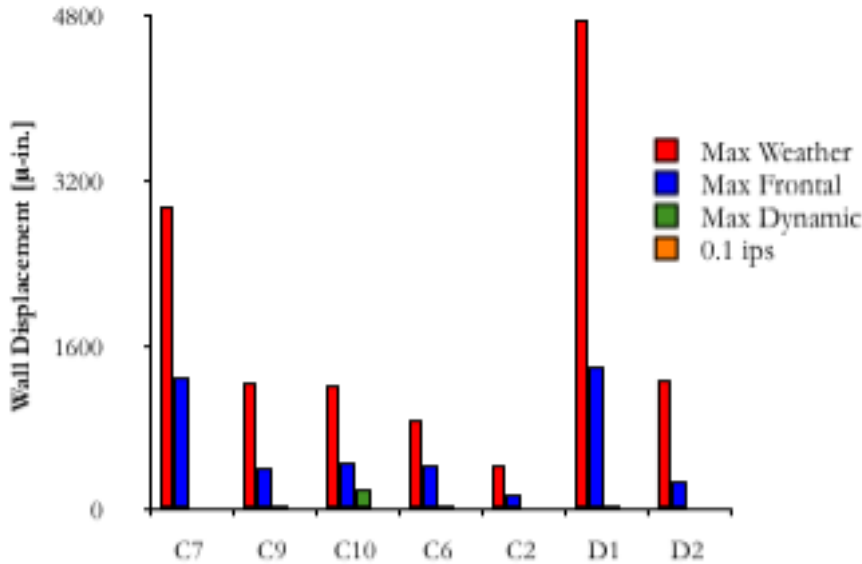
Figure 5 - Bar chart comparison of crack/joint/sheet response induced by weather

The relationship between vibratory and climatological response for uncracked wall weakness (dry wall joints) is the same as for cracks as shown by the bar chart comparisons in **Figure 5**. Where climatological response is small, so is vibratory response for both cracked and uncracked joints. Cracking of a joint does not appear to diminish its dynamic response; at least not relative to other uncracked weaknesses such as the joints. Cracked joints are seen to respond more than uncracked joints to both vibratory and climatological drivers. Large response of cracks is not unexpected. The cracking of wall covering provided by the drywall and its weakest element, the paper thin joints, can often be a function of the structural deformation beneath “the wall cover.” Deformation of the underlying structural interface or element is unlikely to be affected significantly by a thin covering.
