RESPONSE OF CRACKS TO CONSTRUCTION VIBRATIONS AND ENVIRONMENTAL EFFECTS

Charles H. Dowding¹, M ASCE and Mickey L. Snider², M ASCE

ABSTRACT

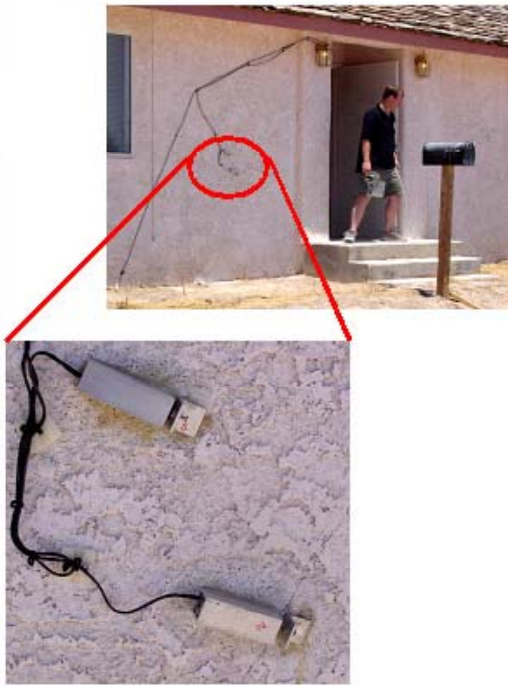
Figure 1 Test House Showing Closeness of Construction and Sensor Across Crack 2

Location of the ranch house in Figure 1 on the right of way of road construction provided the opportunity to test the ACM approach for typical construction activity where soil transmission distances were as small as 8 ft (2.5 m). The one-story stucco covered ranch house was located immediately adjacent to the widening and reconstruction of West Ann Road in Las Vegas, Nevada. The interior walls are constructed of drywall over a wood-frame and the exterior is covered by southwestern-style stucco. The house is in generally good condition, with the majority of the cosmetic cracking on the exterior stucco.

Instrument locations are indicated on the photographs in Figure 1 and plan view in Figure 3. Excitation ground motions were measured by tri-axial (longitudinal, transverse, and vertical) velocity transducers installed in the ground approximately 2 ft (0.6 m) from the south (construction) face of the structure. As with previous studies, the longitudinal direction is defined as parallel to the long axis of the structure. (parallel to Ann Road). Changes in crack width were measured with Macro-sensor LVDT micro-inch displacement sensors shown in Figure 1. All of the crack sensors, as well as the geophones were wired to a Somat eDAQ data acquisition system. This eDAQ provides simultaneous recording of crack response whenever the excitation ground motion exceeds a predetermined trigger level. It also autonomously recorded crack displacement hourly to determine long-term response to environmental effects.

Details of the one of the two external stucco cracks and related sensors are also shown in Figure 1. Sensor 2 spans a vertical crack in the south stucco face of the house, which is parallel to Ann Road and closest to construction. It was so close to construction that the front stairs had to be removed to compact the subbase. The second sensor in the photographs is the null sensor. This sensor measures the non-crack response of the wall material and sensor itself to “null” out any long term drift or systematic response.

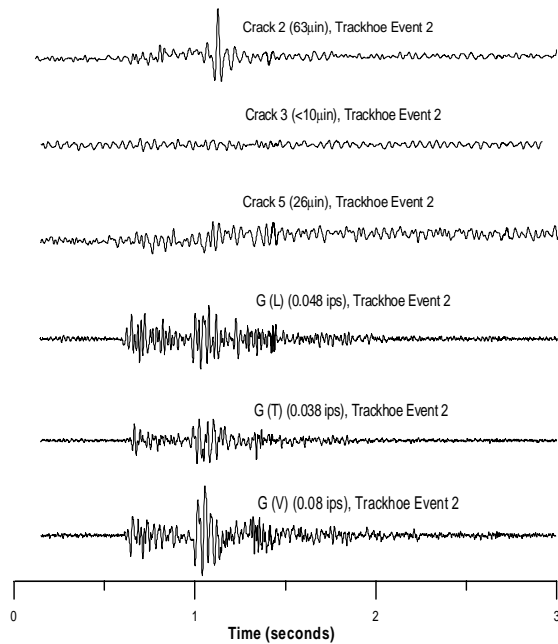
Figure 2 Time Histories of Crack Displacement and Ground Velocity for Trackhoe Excavation

Figure 2 compares time histories of excitation ground motions and the

associated crack response produced by the trackhoe excavation of a 12 foot wide trench at a distance of 46 ft (14 m) . Displacement time histories of cracks 2, 3, and 5 are shown at the top, and the longitudinal, transverse, and vertical ground velocity time histories are shown on the bottom. Cracks 2 and 5 are exterior and 3 is in the the interior. This particular event produced the highest trackhoe-induced PPV , 0.08 ips (2mm/s) in the vertical direction. Crack 2, the external south wall crack nearest the

excavation, experienced the greatest displacement of 63 micro-inches zero-to-peak (1.6 micro meters) while

Crack 5 experienced 26 micro-inches zero-to-peak. Internal Crack 3 showed little or no discernable response, even after filtering of general instrument and electrical noise is performed. Attenuation relationships (Aimone, 2002) show that this PPV matches that expected.

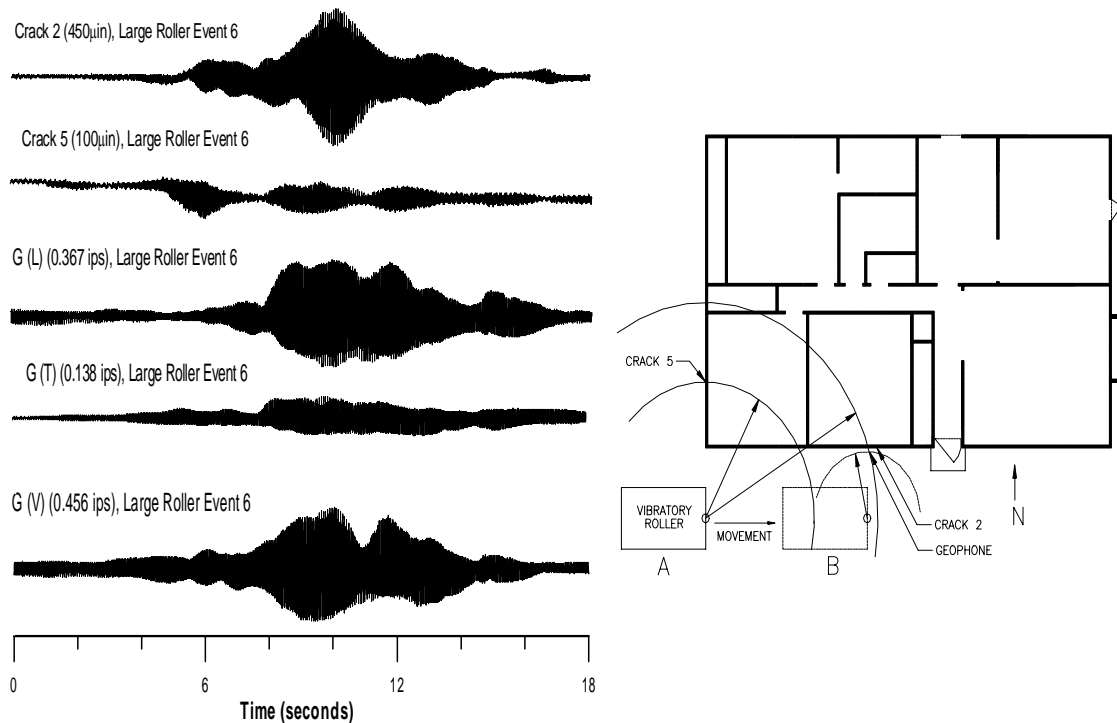
Figure 3 Time Histories of Crack Displacement and Ground (Particle) Velocity Produced by Vibratory Roller Compaction within 3 m of the House

Figure 3 compares time correlated time histories of crack responses (top) with particle velocity excitation of one pass during vibratory compaction of stone sub-grade in front of the house. The sub-grade was compacted with the Ingersall-Rand (IR) Pro-Pack series SD115 soil compactor. The top two time histories are crack displacement time histories, and the bottom three show the corresponding excitation ground velocities. This event produced a PPV of 0.46 ips (12 mm/s) , and resulted from compaction within 8 ft (2.5m) of the south wall. As can be seen, crack displacements varied greatly, with Crack 2 responding the most at 450 μ in.

Differing times of maximum response to close in vibratory rolling in Figure 3 illustrate the local nature of excitation with unusually close construction. While the peak displacement of Crack 2 occurs at roughly the same time as the peak ground motions, the peak response of Crack 5 occurs four to five seconds before the peak ground motions at the velocity transducer. The insert on the right shows that if the roller is moving west to east (as it was during this event), then when the peak motions occur at the wall containing Crack 5, they will be significantly attenuated by the time they reach the velocity transducer some 30 feet (9 m) away. In blast cases the origin of the perturbation is sufficiently distant that the radius of curvature of the excitation front is sufficiently large that the ground motion wave front arrives simultaneously everywhere on the responding structure. Thus all portions of the structure will respond relatively simultaneously (Dowding and Snider, 2003).

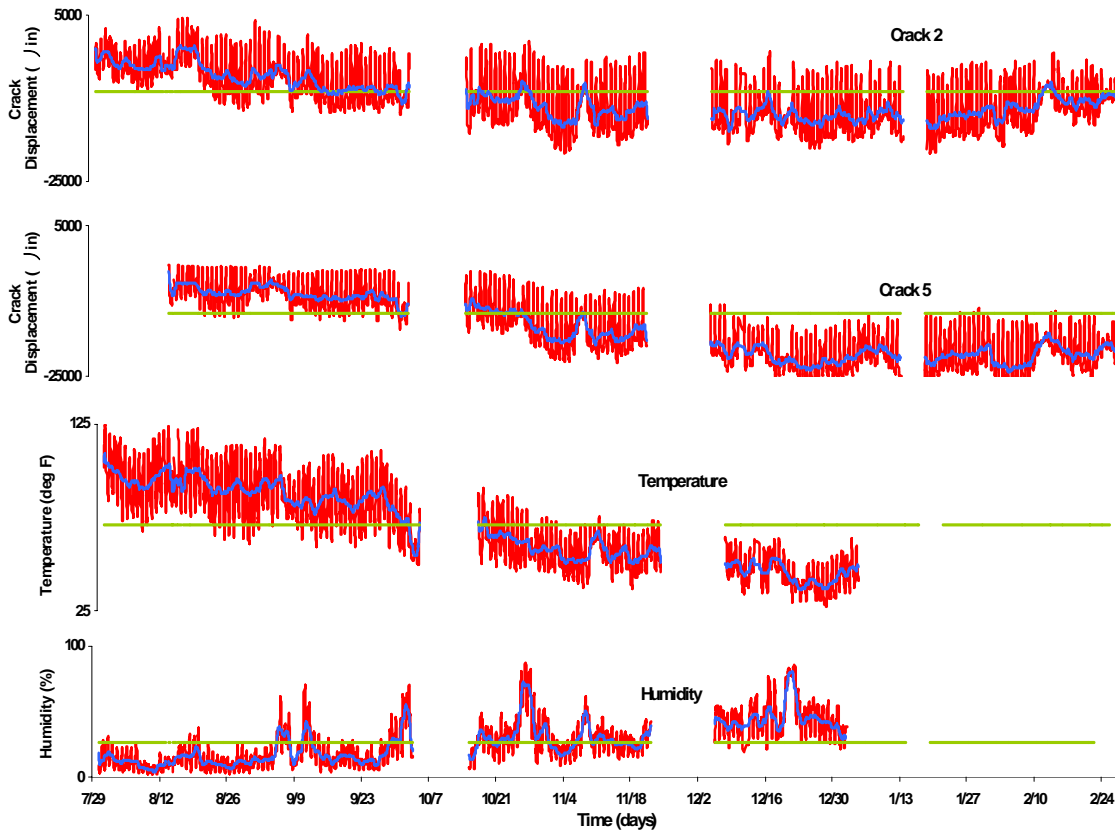
Figure 4 Long Term μ in Crack Displacement, Temperature and Humidity vs Time, Showing Effects of Changes in Seasonal, Frontal, Rainfall, and Daily Weather Changes

Figure 4 compares the time variation of long-term response of outside cracks 2 & 5 with long-term outside temperature and humidity weather indicators for each crack. Space prohibits display of a similar figure for the inside cracks. See Sinder (2003) for more details of other responses. Large daily changes in temperature as well as those produced by the passage of weather fronts, particularly outdoors, are characteristic of Nevada's desert climate. These weather phenomena correlate well with both large, sharp daily changes and the more slowly changing frontal and seasonal response of

Several notable weather events occurred during the collection of the long-term data. Most importantly these measurements spanned the fall months with steadily dropping average temperatures. As would be expected average crack displacement also declined, which indicates that the cracks tended to close. Significant increases in humidity and declinations in temperature, such as those seen around the 11th of September, 27th of October and 21st of December during rainfalls of 0.27, 0.17, and 0.06 in. (7, 4 & 1.5 mm) respectively. During these rain storms the 24-hour rolling humidity average steadily increased and crack 2 responded the most.

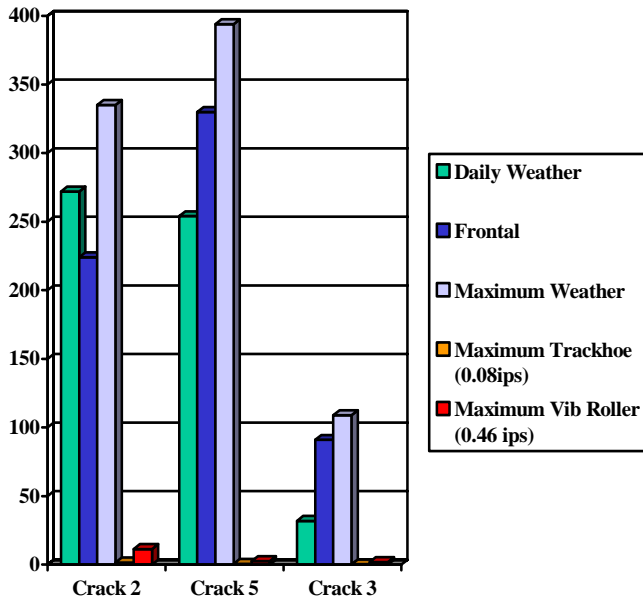
Figure 5 Comparison of Crack Displacements from Maximum Weather (Tall Bars) and Construction Vibration Effects (Short Bars) for Cracks 2, 3 & 5

Average and maximum responses of three cracks can be seen in Figure 5 for each weather descriptor: frontal (24 hour rolling average minus overall average) , daily

(daily maximum/minimum minus the 24 hour rolling average), and seasonal/maximum (maximum minus the overall average) . These descriptions follow previous approaches (Siebert and Dowding , 2000, Louis, 2001, and McKenna, 2002). The disparity in magnitude between internal and external crack displacement is expected, as the interior of the house is temperature and humidity controlled and out of the influence of direct sunlight. Within any 24 hour period external walls containing cracks are subjected to changes in temperature as large as 50 degrees F and humidity changes of as much as 40 percent.

Weather-induced crack displacement for all cracks as defined by the three weather descriptors was at least a factor of ten larger than any vibration-induced displacement, and often much more. The weather induced responses of cracks 2, 3 & 5 are compared to those produced by vibration in Figure 8. Despite the vibration of the structure at a PPV of 0.46 ips (12 mm/s) by roller compaction, the weather induced crack displacement still dominates.

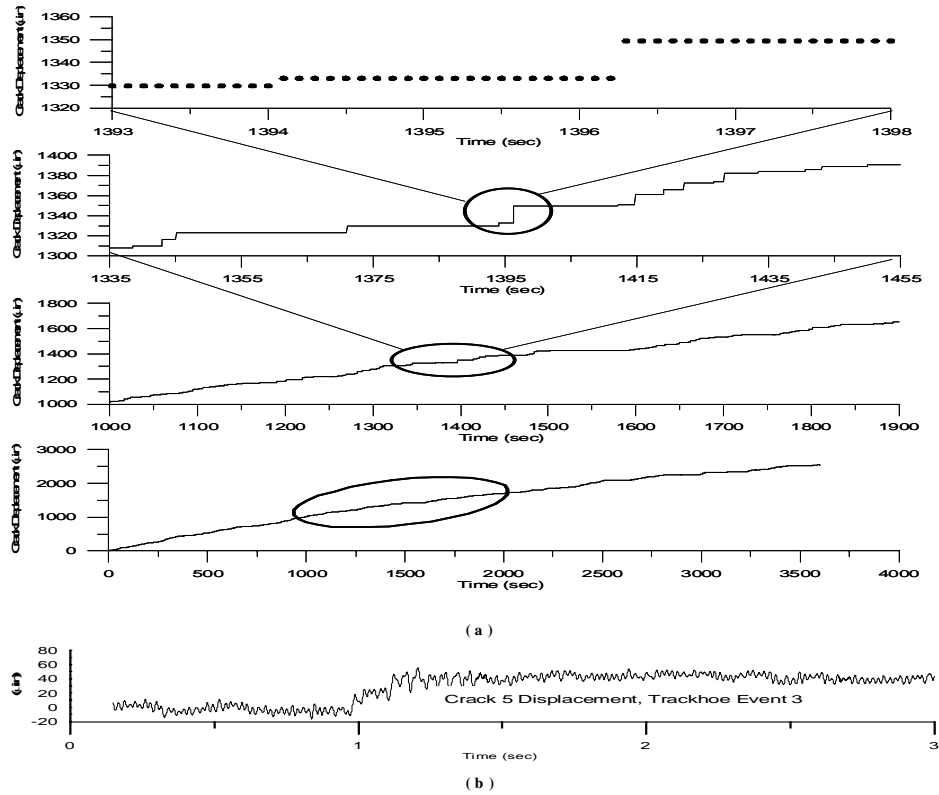
Figure 6 Stick-Slip Behavior of Crack Displacement and Potential Misinterpretation of Effect of Vibratory Crack Response

Cracks do not open and close in a continuously smooth fashion, but rather intermittently over time in a stick-slip fashion. Figure 6 (a) shows five seconds of external Crack 5 data recorded at a rate of 10 samples per second (10 Hz), at approximately 8:30 AM on a day when no construction activity significant enough to trigger vibratory response took place in the vicinity of the house. This stick-slip phenomenon may influence the interpretation of vibratory response if it occurs during a stick-slip event. As shown by the vibratory response in Figure 6 (b), there may be the appearance of what might be mistakenly interpreted as “permanent” crack displacement in a recorded time history. However, this jump would have occurred without the vibratory excitation as shown in the upper three time histories of crack displacement. The upper time histories portray increasingly narrow time windows that eventually show the stick slip jump in the change in crack width over a 5 second

time span. More importantly, the continuing opening of the crack shown by the 4000 second long measurement, completely overwhelms the stick-slip and possible misinterpreted vibratory offset.

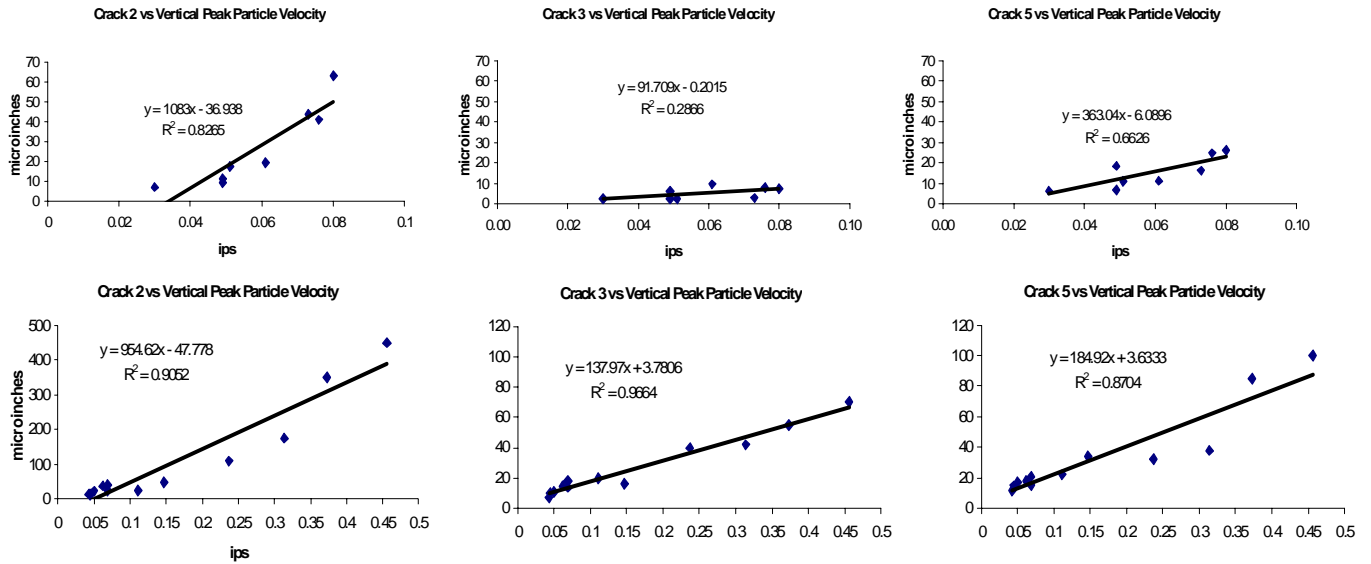
Figure 7 Correlation of Crack Displacement in micro inches (y axis) with Peak Particle Velocity (ips) (1 ips = 25 mm/s) (x axis) for Cracks 2, 3 & 5 for Trackhoe (top row) and Vibratory Roller Excitation (bottom row)

Comparison of PPV and crack displacement presented in Figure 7 show that crack displacement is correlated with PPV. While correlation exists for both trackhoe and vibratory compaction excitation, it is the strongest for vibratory compaction. Four of the compaction events included in Figure 7, involved passage of the roller within 10 feet of the house, an atypically small stand-off distance. These events made it

possible to examine and correlate excitation PPV and crack response for a broad and complete range of peak particle velocities, much like traditional blasting studies.
